BUILDING ENERGY/HEAT LOSS INFRARED INSPECTION REPORT

The Any Company Inc.
123 Any Drive
Chicago, IL

January 1, 2012

Job Number: 1234E-09

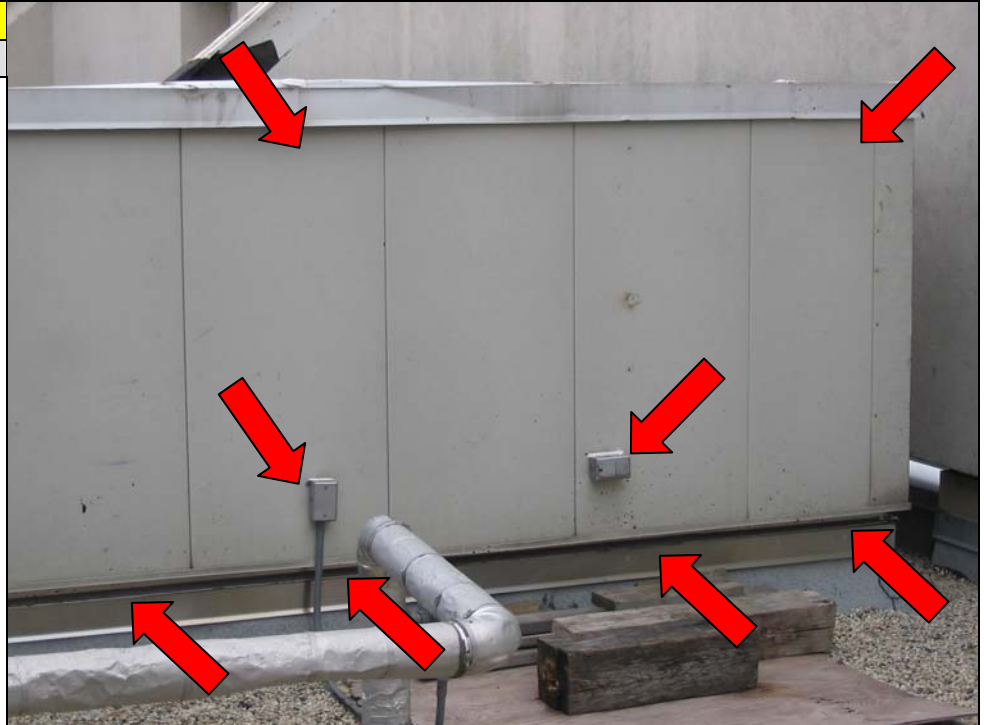
IMAGE No.01

Location: Image No. 01 view is of the penthouse west elevation, looking east.
Note: Refer to satellite image for approximate photo location and viewing angle.

Description: Image No. 01 documents the location (see red arrows in top photo) of surface thermal differences for selective building surface area(s). (see bottom thermal photo) Investigation of this area is recommended to determine cause of thermal differences

Thermal differences may be caused by missing/poorly fitted insulation, caulking deficiencies and/or construction design.

Investigation of this area is recommended to determine if corrective action is warranted.

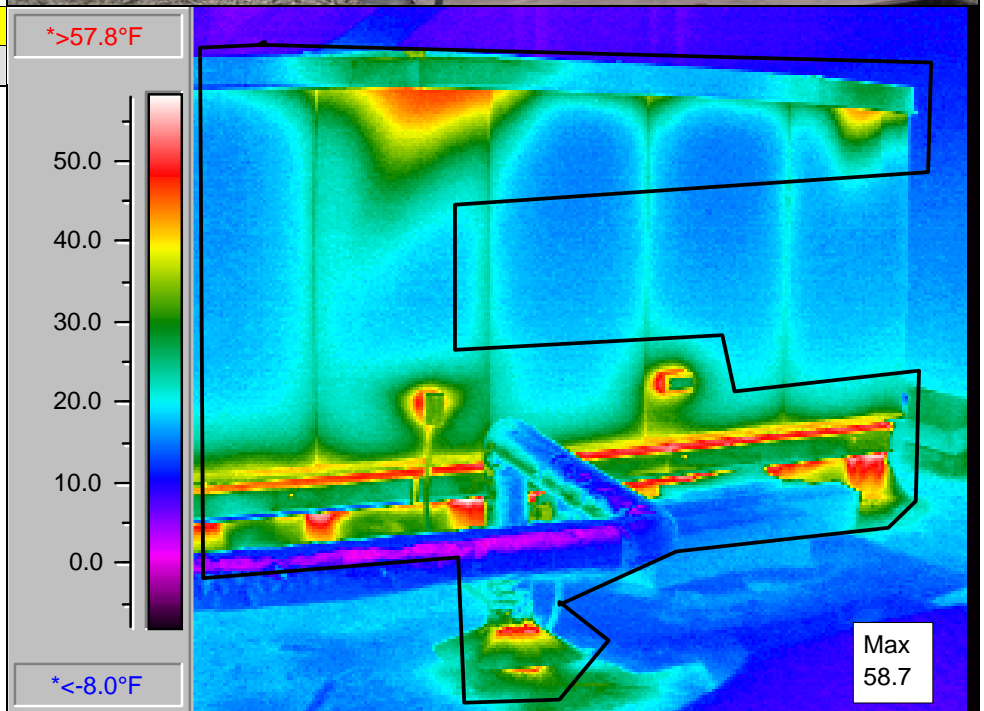
IMAGE No.01

Nighttime infrared thermal color photograph (at right) documents surface thermal differences.

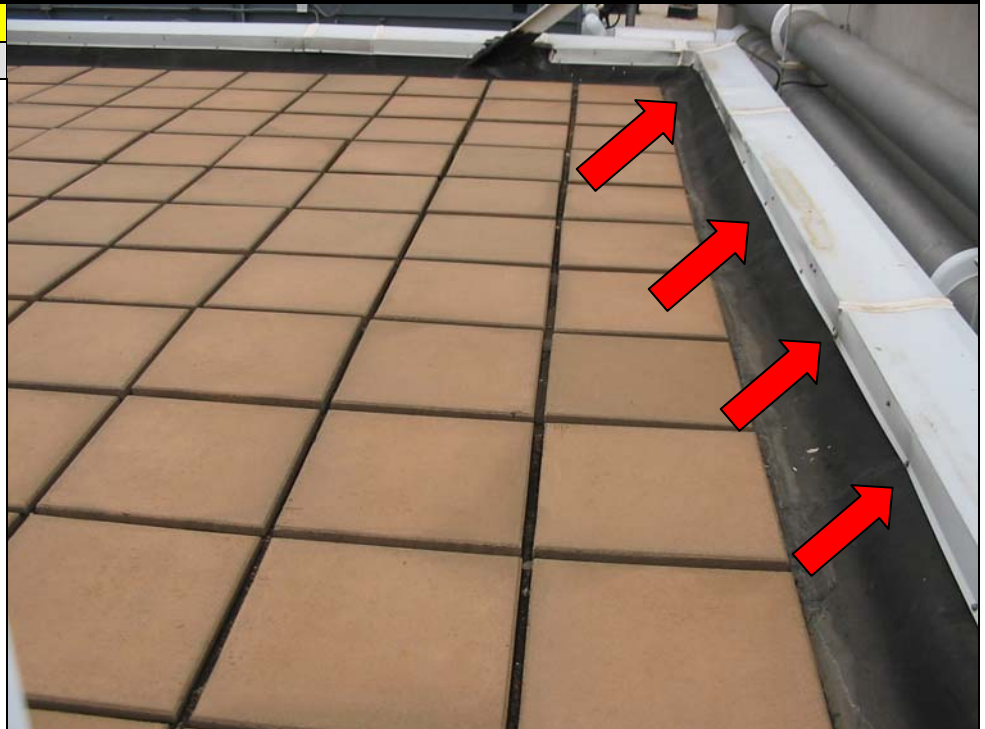
IMAGE No.02

Location: Image No. 2 view is of the penthouse north elevation roof edge, looking west.
Note: Refer to satellite image for approximate photo location and viewing angle.

Description: Image No. 2 documents the location (see red arrows in top photo) of surface thermal differences for selective building surface area(s).(see bottom thermal photo)
Investigation of this area is recommended to determine cause of thermal differences

Thermal differences may be caused by missing/poorly fitted insulation, caulking deficiencies and/or construction design.

Investigation of this area is recommended to determine if corrective action is warranted.

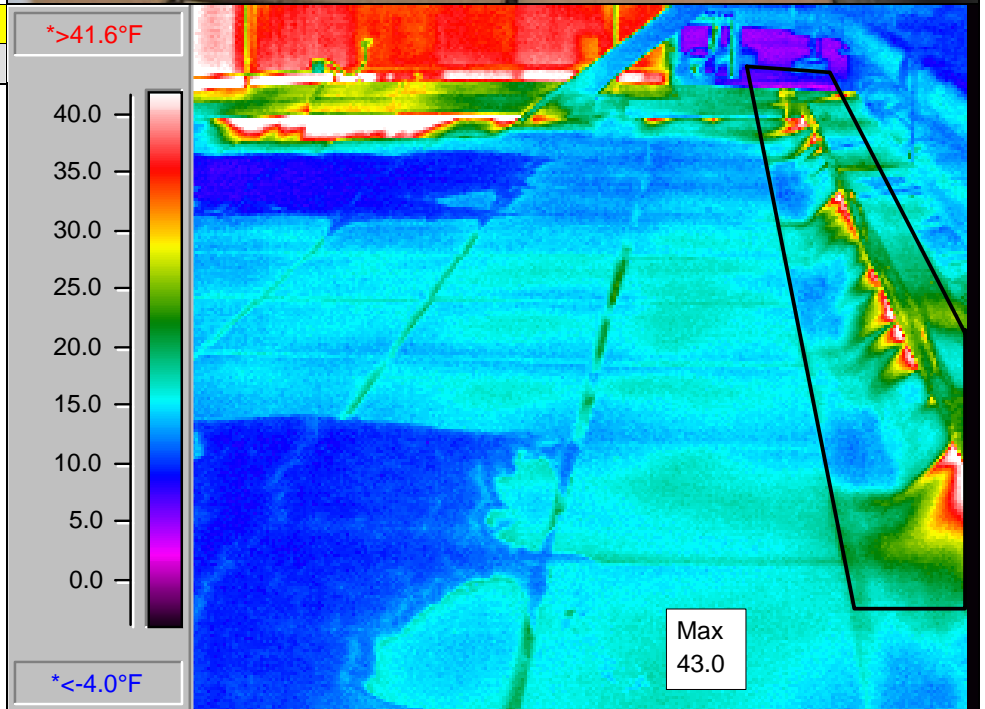
IMAGE No.02

Nighttime infrared thermal color photograph (at right) documents surface thermal differences.

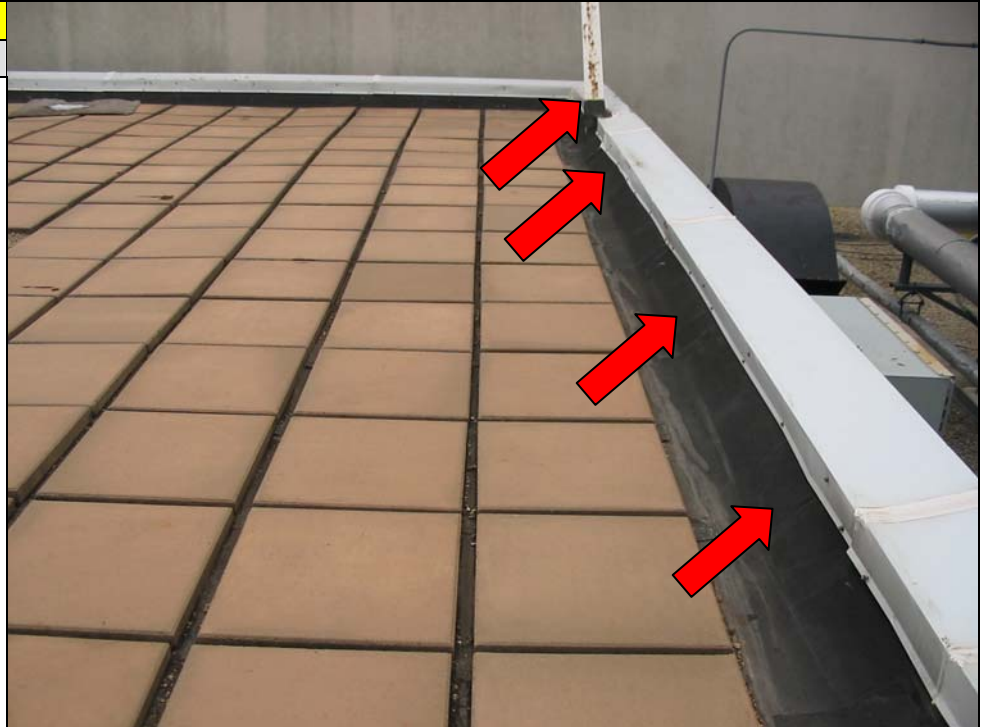
IMAGE No.03

Location: Image No. 03 view is of the penthouse west elevation roof edge, looking south.
Note: Refer to satellite image for approximate photo location and viewing angle.

Description: Image No. 03 documents the location (see red arrows in top photo) of surface thermal differences for selective building surface area(s). (see bottom thermal photo)
Investigation of this area is recommended to determine cause of thermal differences

Thermal differences may be caused by missing/poorly fitted insulation, caulking deficiencies and/or construction design.

Investigation of this area is recommended to determine if corrective action is warranted.

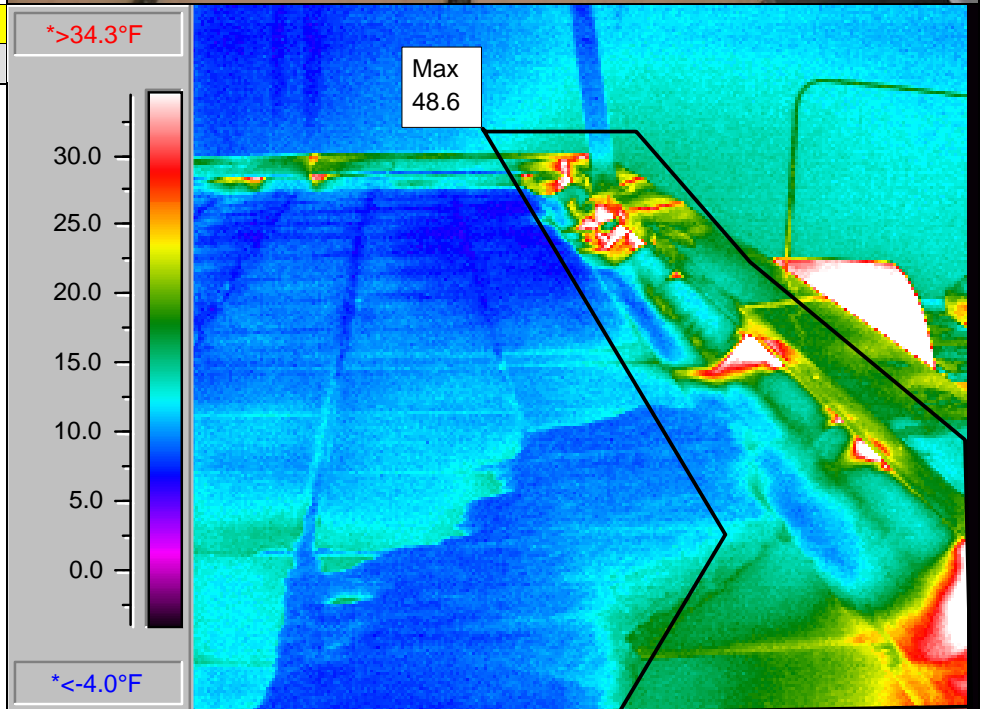
IMAGE No.03

Nighttime infrared thermal color photograph (at right) documents surface thermal differences.

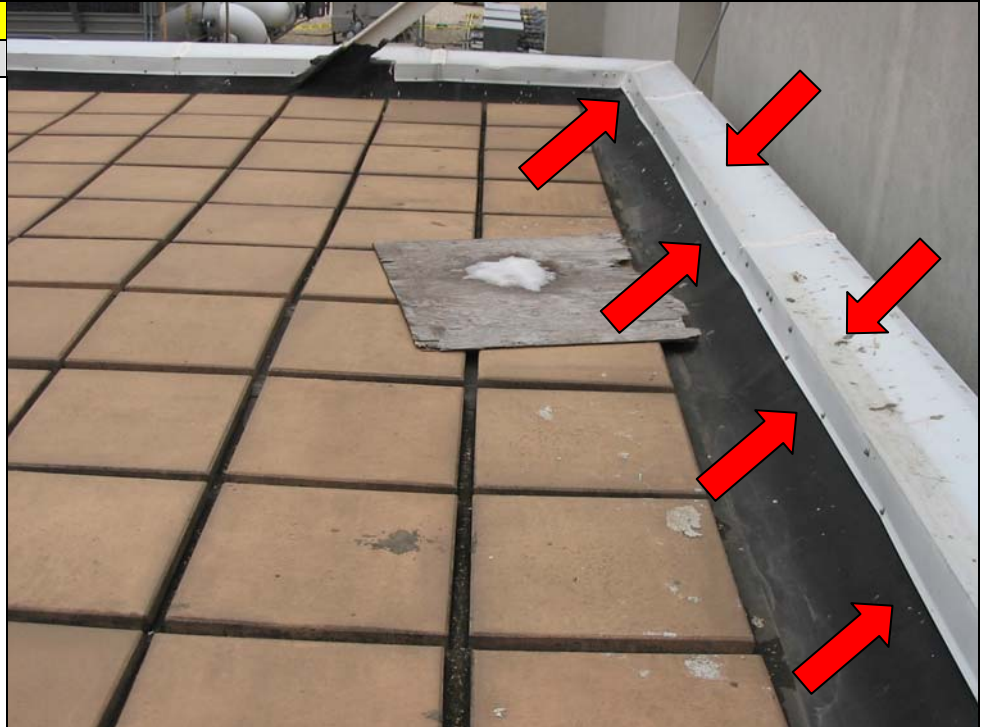
IMAGE No.04

Location: Image No. 04 view is of the penthouse south elevation roof edge, looking east.
Note: Refer to satellite image for approximate photo location and viewing angle.

Description: Image No. 04 documents the location (see red arrows in top photo) of surface thermal differences for selective building surface area(s).(see bottom thermal photo)
Investigation of this area is recommended to determine cause of thermal differences

Thermal differences may be caused by missing/poorly fitted insulation, caulking deficiencies and/or construction design.

Investigation of this area is recommended to determine if corrective action is warranted.

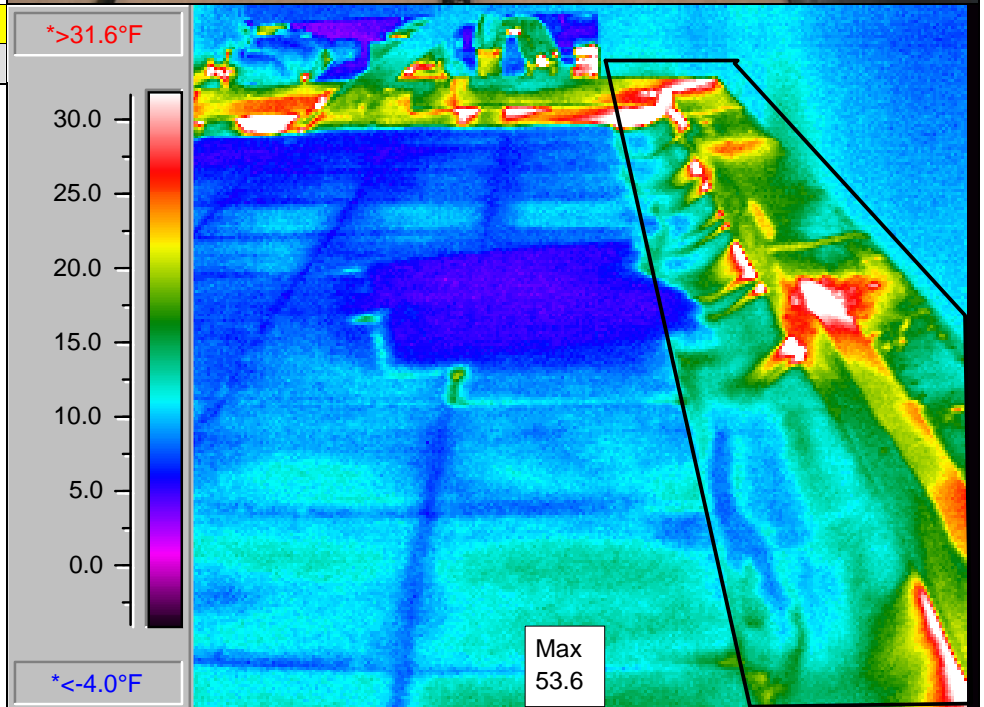
IMAGE No.04

Nighttime infrared thermal color photograph (at right) documents surface thermal differences.

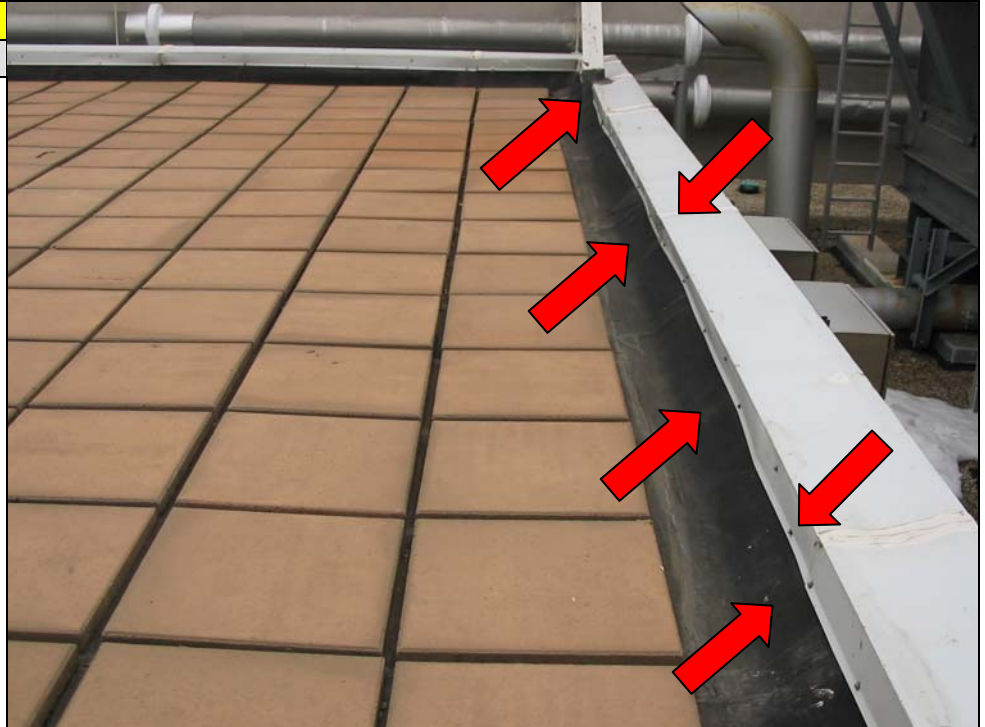
IMAGE No.05

Location: Image No. 05 view is of the penthouse east elevation roof edge, looking north.
Note: Refer to satellite image for approximate photo location and viewing angle.

Description: Image No. 05 documents the location (see red arrows in top photo) of surface thermal differences for selective building surface area(s).(see bottom thermal photo)
Investigation of this area is recommended to determine cause of thermal differences

Thermal differences may be caused by missing/poorly fitted insulation, caulking deficiencies and/or construction design.

Investigation of this area is recommended to determine if corrective action is warranted.

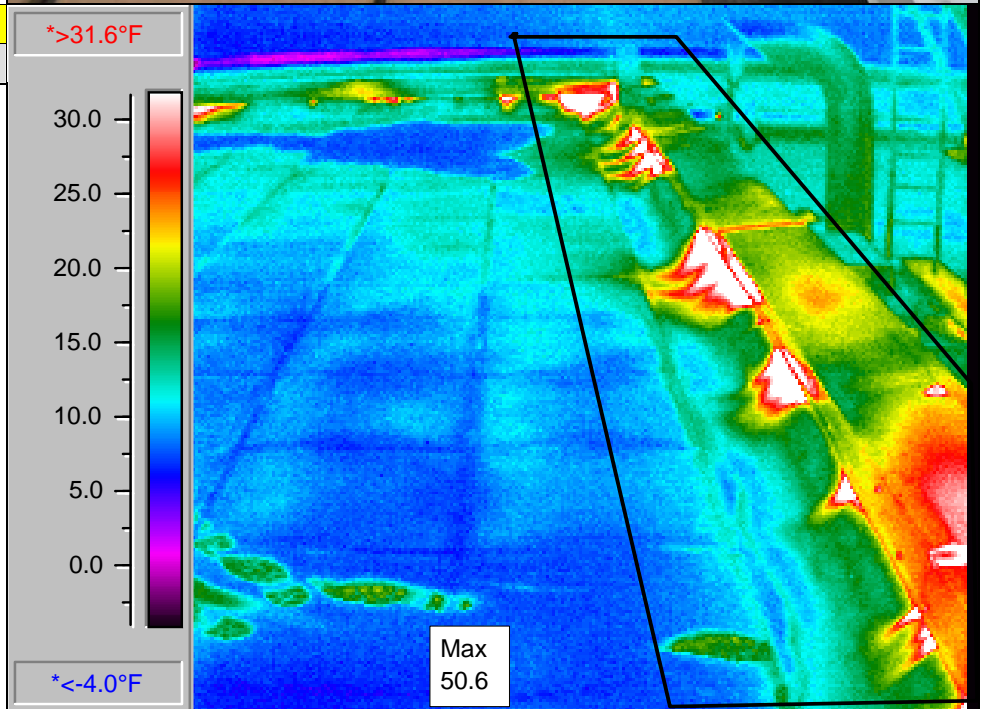
IMAGE No.05

Nighttime infrared thermal color photograph (at right) documents surface thermal differences.

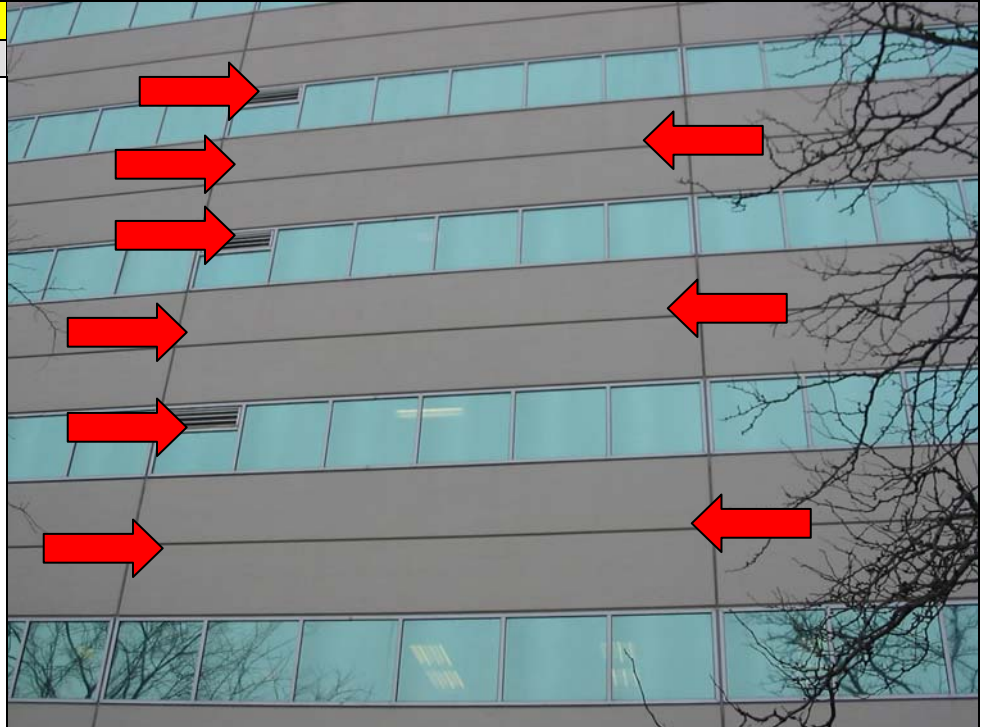
IMAGE No.06

Location: Image No. 06 view is of the south elevation, west side of building
Note: Refer to satellite image for approximate photo location and viewing angle.

Description: Image No. 06 documents the location (see red arrows in top photo) of surface thermal differences for selective building surface area(s).(see bottom thermal photo)
Investigation of this area is recommended to determine cause of thermal differences

Thermal differences may be caused by missing/poorly fitted insulation, caulking deficiencies and/or construction design.

Investigation of this area is recommended to determine if corrective action is warranted.

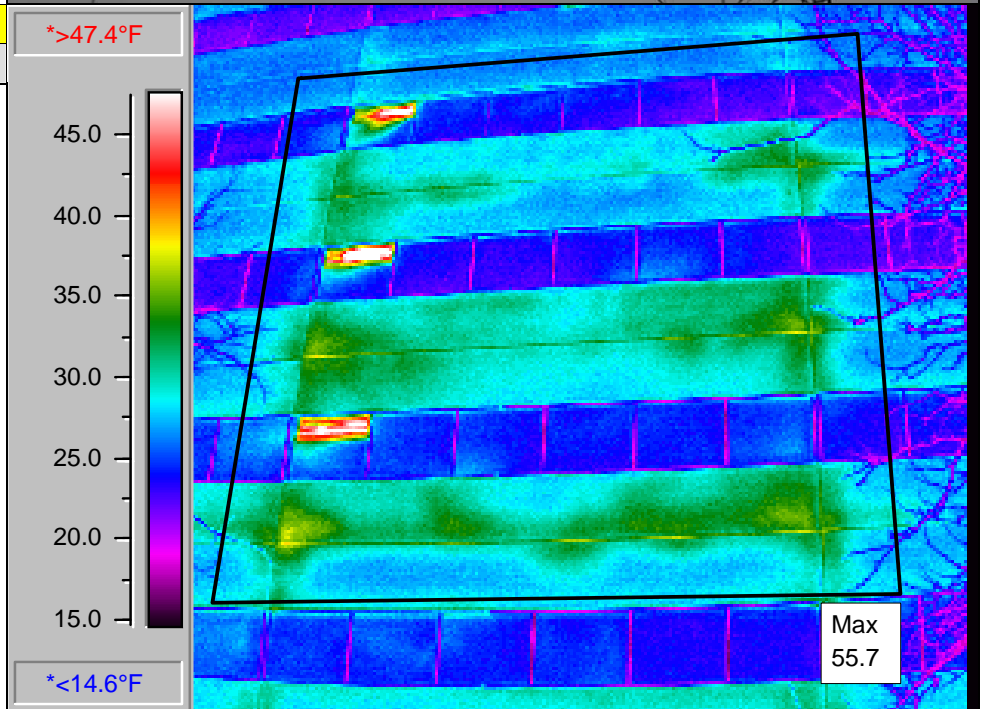
IMAGE No.06

Nighttime infrared thermal color photograph (at right) documents surface thermal differences.

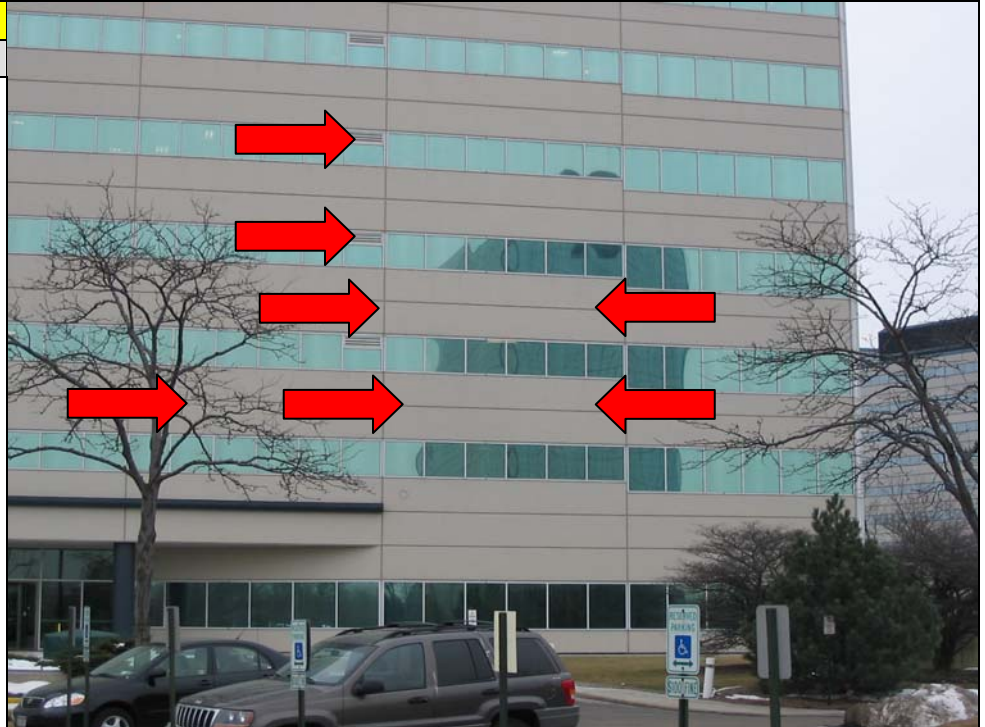
IMAGE No.07

Location: Image No. 07 view is of the north elevation, west side of building.
Note: Refer to satellite image for approximate photo location and viewing angle.

Description: Image No. 07 documents the location (see red arrows in top photo) of surface thermal differences for selective building surface area(s).(see bottom thermal photo)
Investigation of this area is recommended to determine cause of thermal differences

Thermal differences may be caused by missing/poorly fitted insulation, caulking deficiencies and/or construction design.

Investigation of this area is recommended to determine if corrective action is warranted.

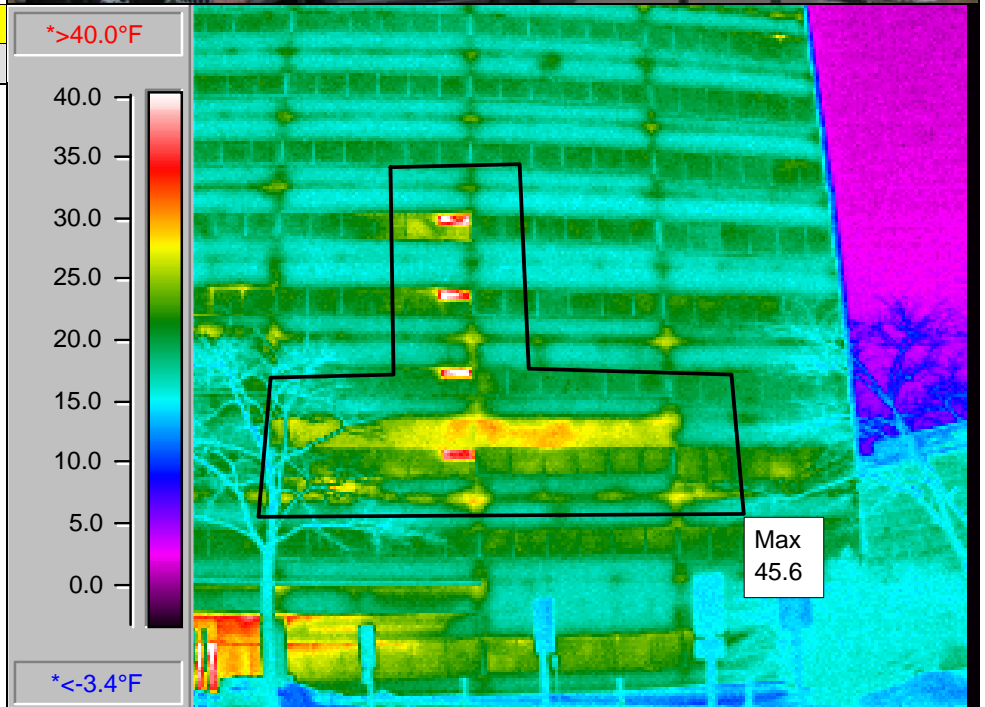
IMAGE No.07

Nighttime infrared thermal color photograph (at right) documents surface thermal differences.

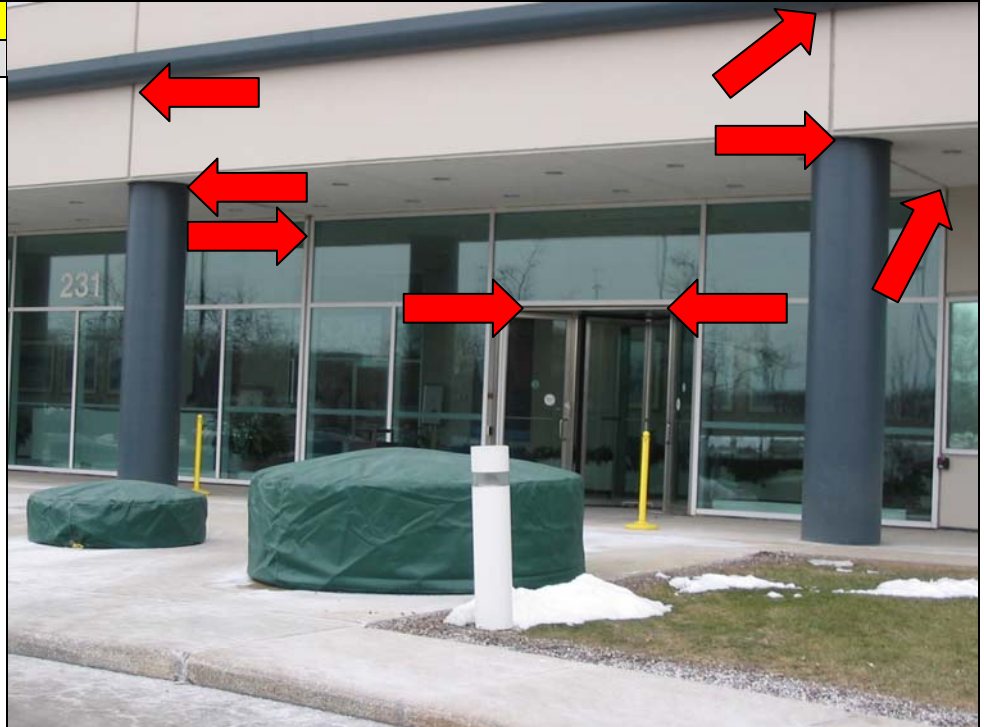
IMAGE No.08

Location: Image No. 08 view is of the north elevation, entryway & canopy.
 Note: Refer to satellite image for approximate photo location and viewing angle.

Description: Image No. 08 documents the location (see red arrows in top photo) of surface thermal differences for selective building surface area(s). (see bottom thermal photo) Investigation of this area is recommended to determine cause of thermal differences

Thermal differences may be caused by normal building HVAC operation, diffusion of heat on window surfaces and/or discharge air through vents.

Investigation of this area is recommended to determine if any corrective action is warranted.

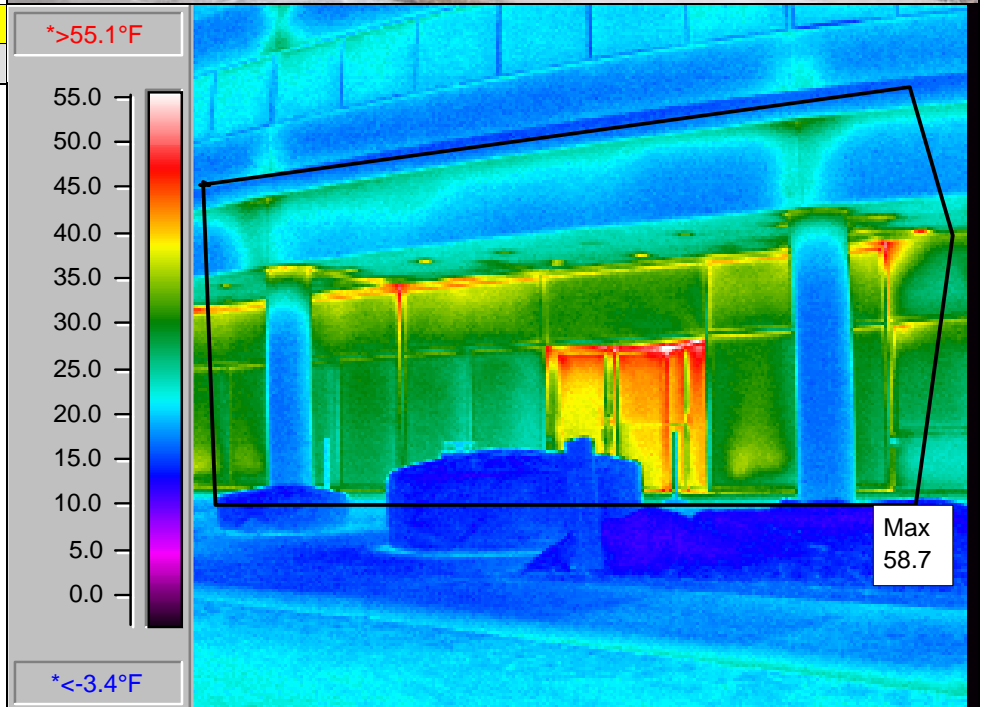
IMAGE No.08

Nighttime infrared thermal color photograph (at right) documents surface thermal differences.
