BUILDING ENERGY/HEAT LOSS INFRARED INSPECTION REPORT

The Any Company Inc.
123 Any Drive
Chicago, IL

January 1, 2012

Job Number: 1234E-09

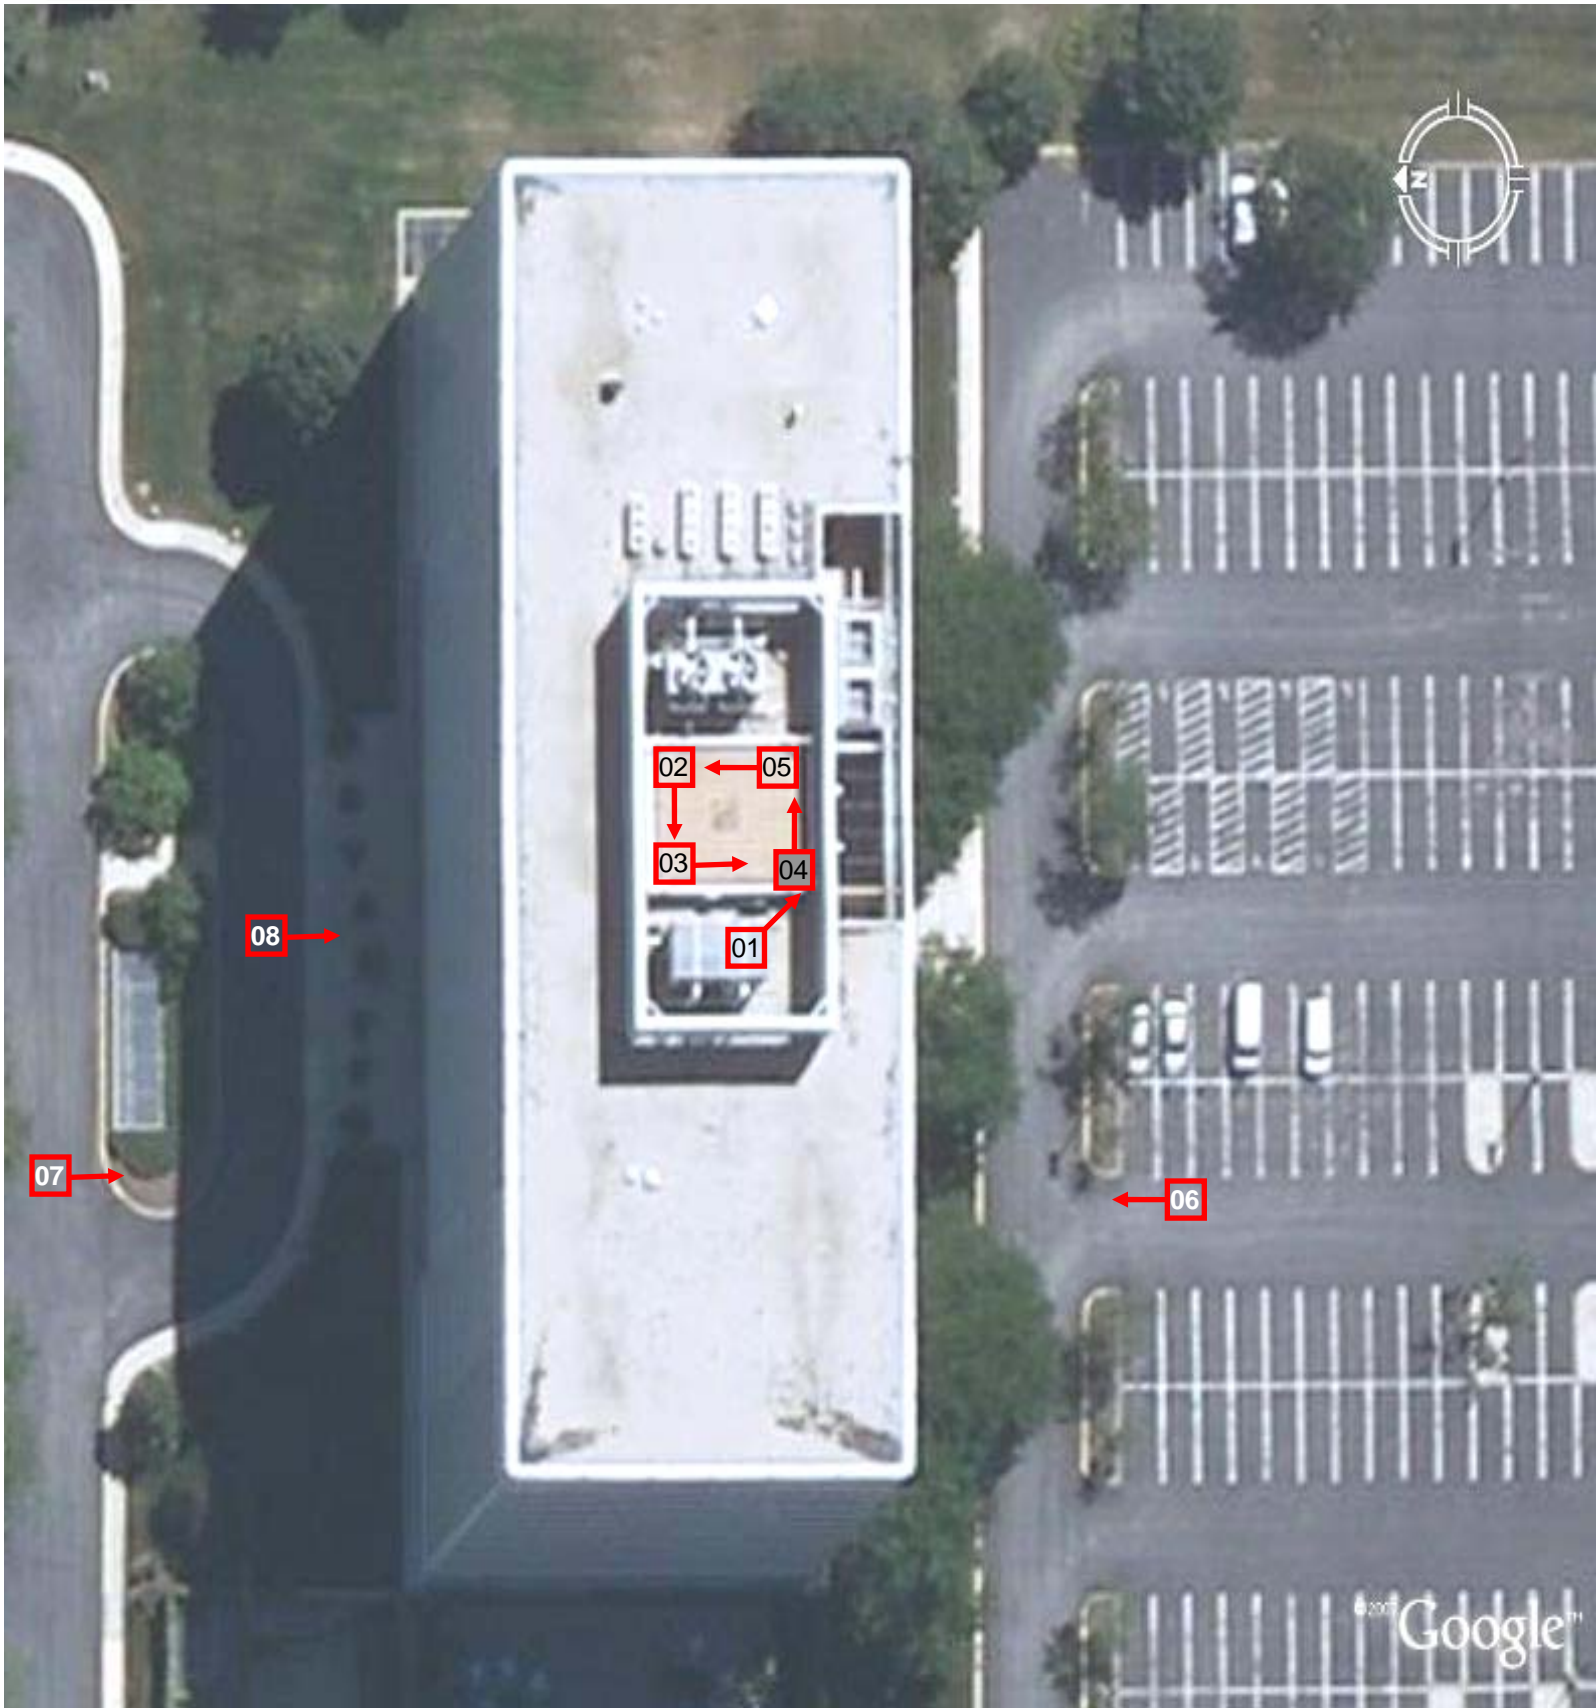
← 01 = Approximate photo location and viewing angle.

Description: Image No. 01 documents the location (see red arrows in top photo) of surface thermal differences for selective building surface area(s). (see bottom thermal photo) Investigation of this area is recommended to determine cause of thermal differences

Thermal differences may be caused by missing/poorly fitted insulation, caulking deficiencies and/or construction design.

Investigation of this area is recommended to determine if corrective action is warranted.
